**CONSENT ORDER
ISSUED UNDER THE
WATER POLLUTION CONTROL ACT
WEST VIRGINIA CODE, CHAPTER 22, ARTICLE 11**

TO: MarkWest Liberty Midstream & Resources, L.L.C. DATE: March 28, 2019
Gregory Bezdek, SVP, NE Region
4600 J Barry Ct. Ste 500
Canonsburg, PA 15317 ORDER NO.: 8945

MARKWEST LIBERTY MIDSTREAM & RESOURCES, L.L.C, WVR311004, Sherwood to Mobley
20" NGL, 8/22 & 8/23/2018

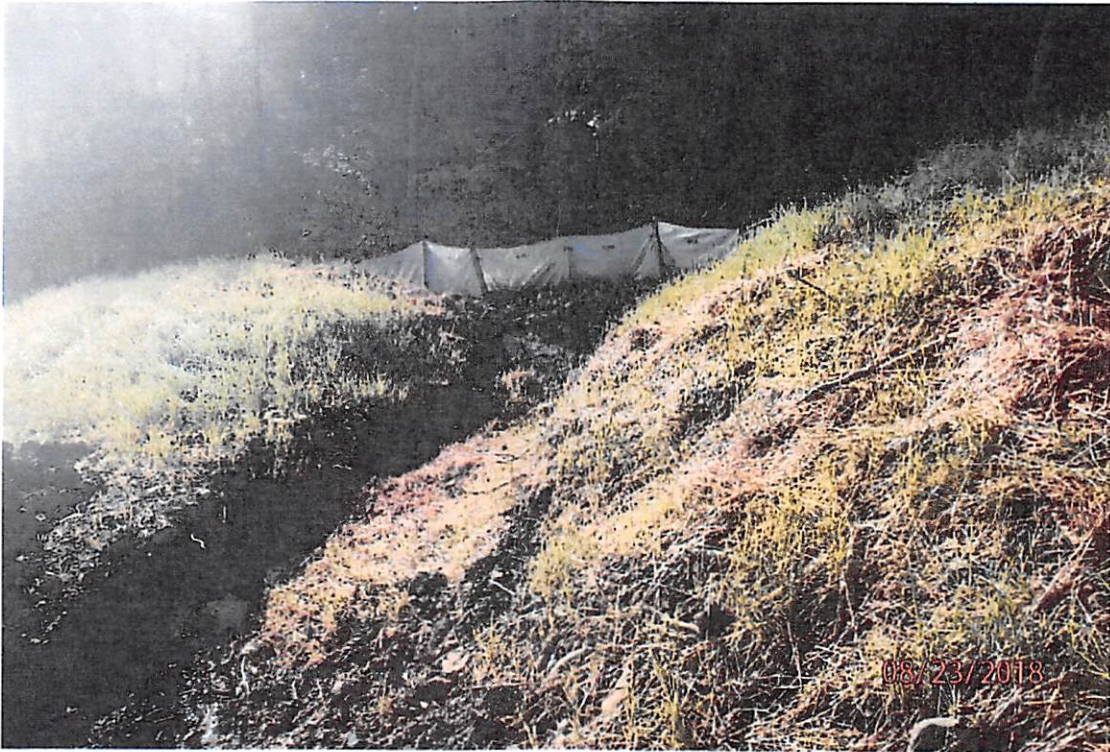
Overwhelmed water bar terminus BMP as a result of excessive erosion and increased water velocity from the above pictured water bar.

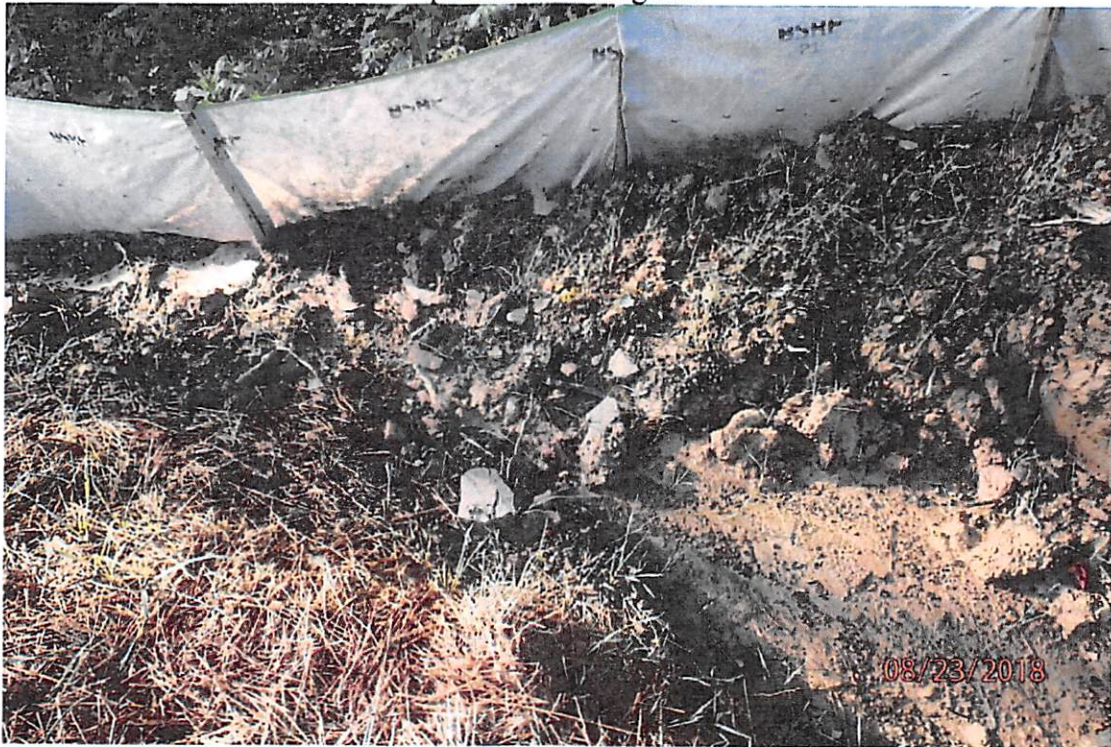
Improperly installed water bar near 857+00 that does not shed stormwater off of the LOD in small quantities as designed.

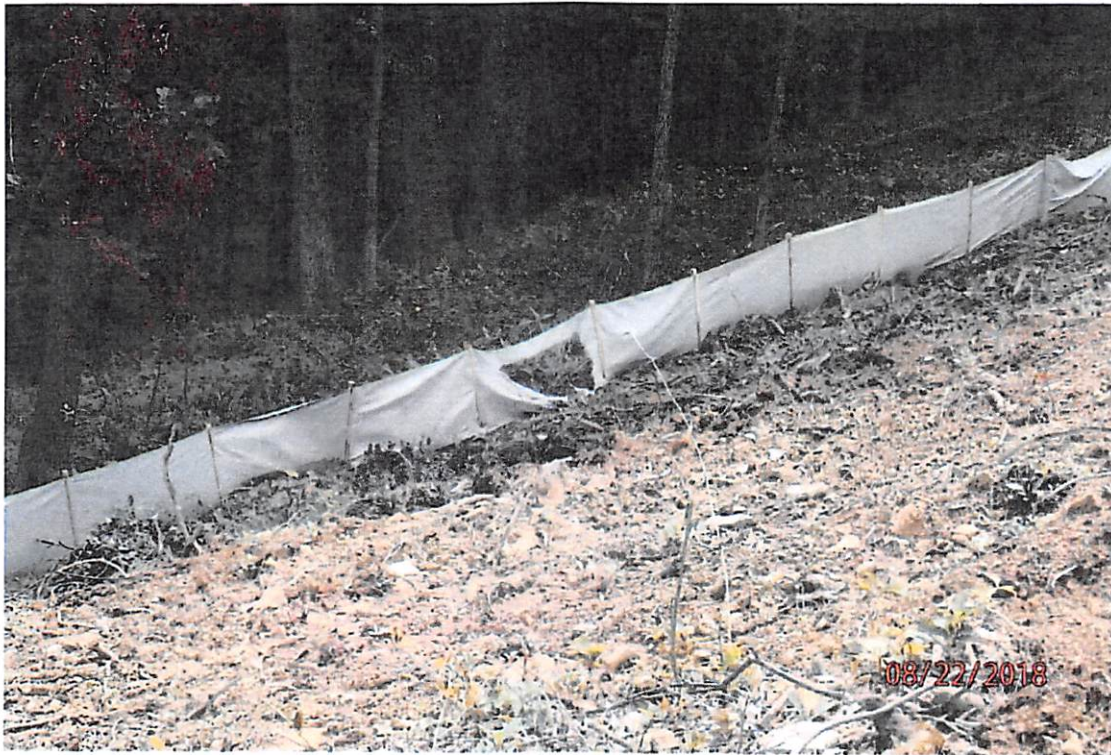
Improperly installed water bar near 857+00 that terminates prior to the installed perimeter controls and does not shed stormwater off of the LOD in small quantities as designed.

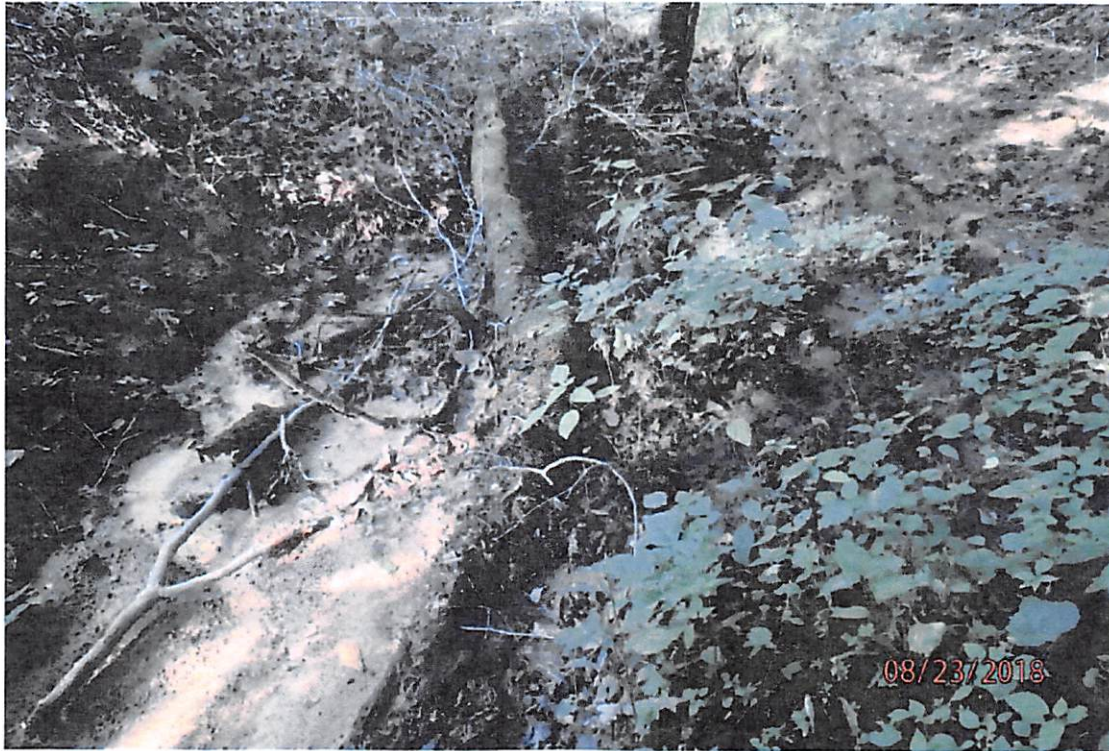
Offsite sediment deposits that lead to the receiving stream as a result of the above pictured deficiency.

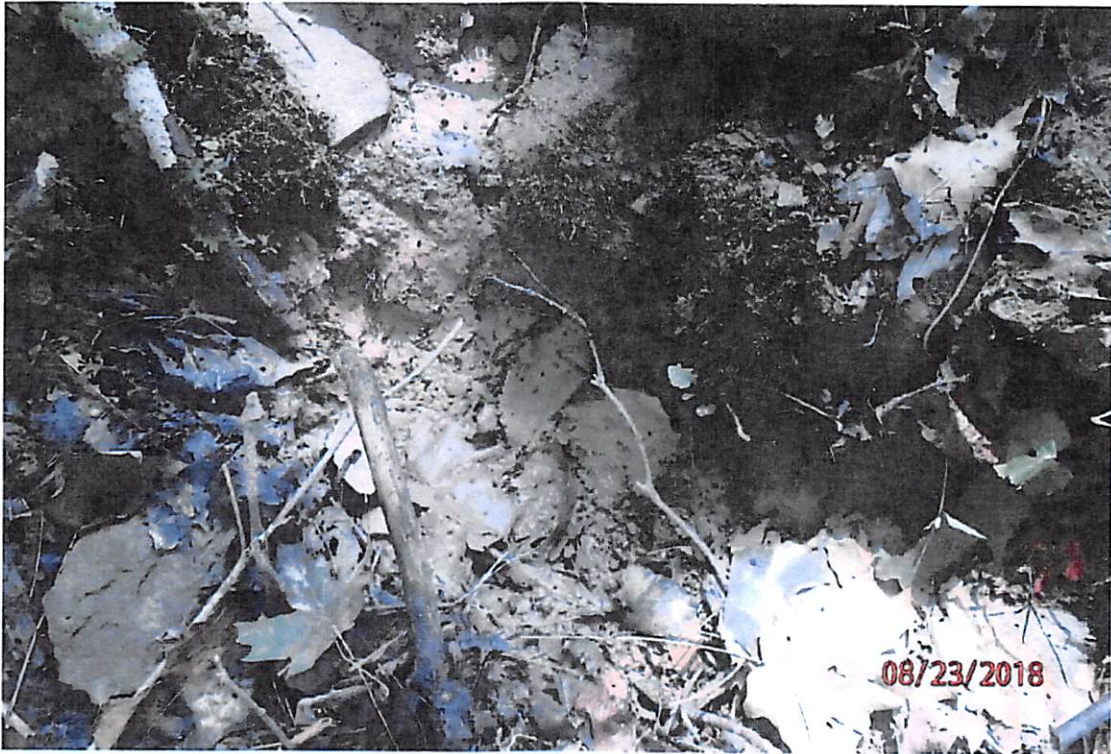
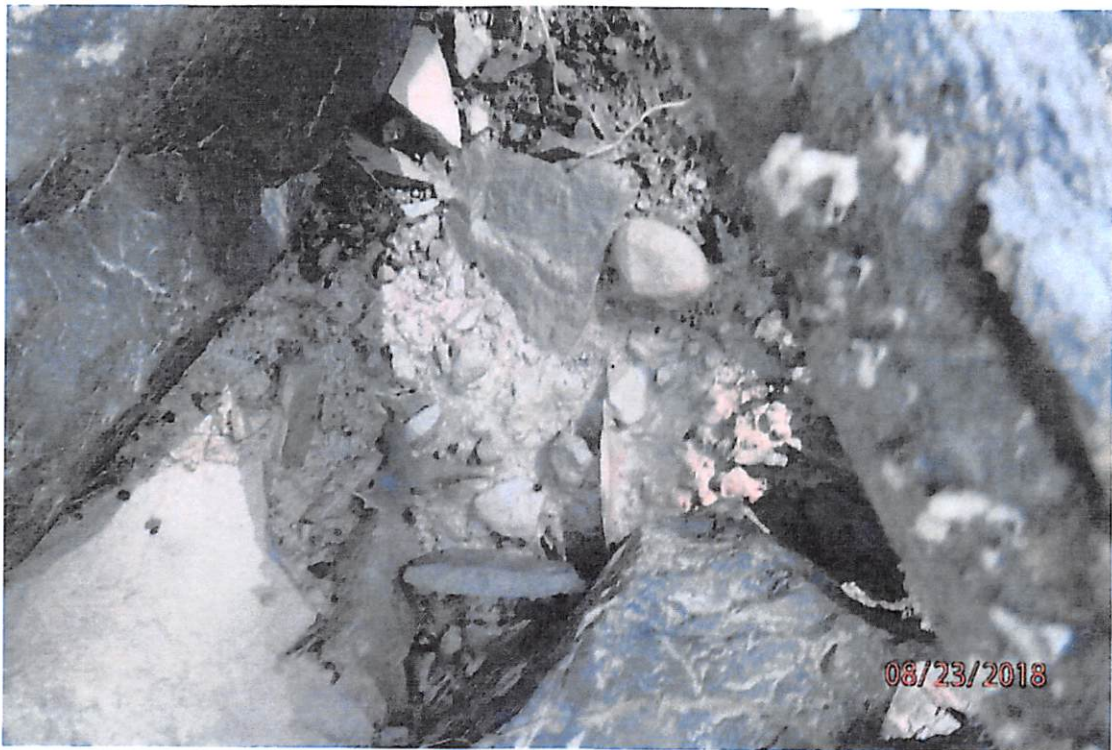
Offsite sediment deposits that lead to the receiving stream as a result of the above pictured BMP.

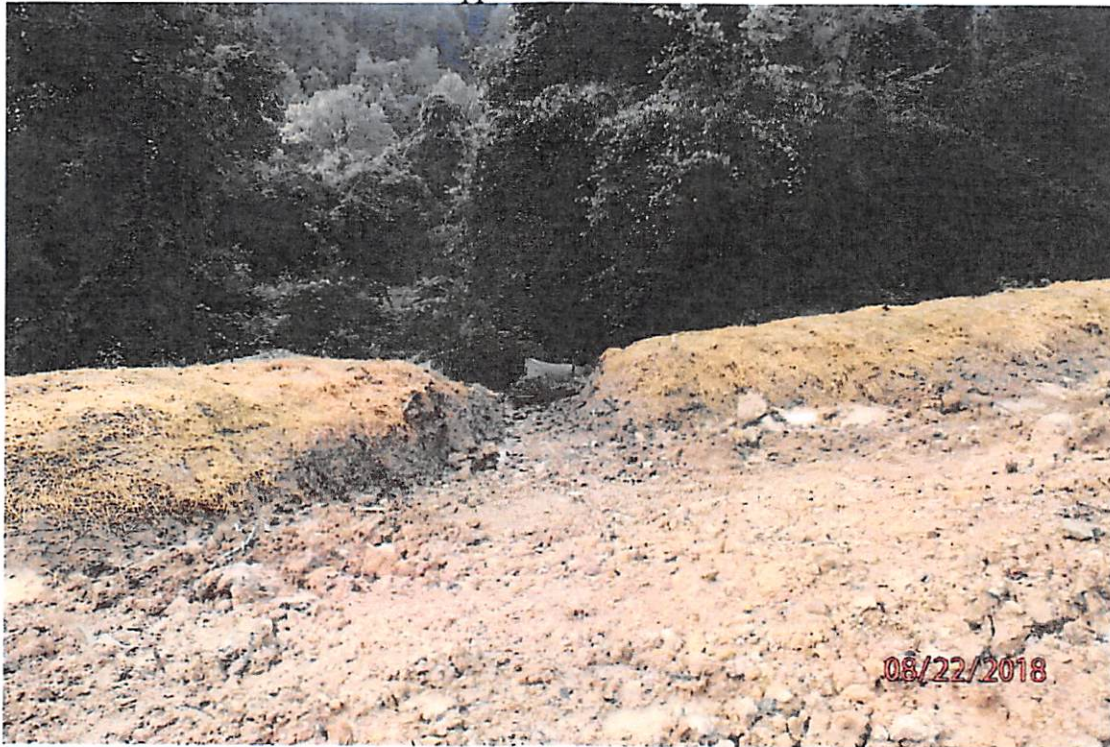
Installed diversion berm near 57+00 that lacks adequate outlets. Area also lacks water bars on the approved SWPPP.

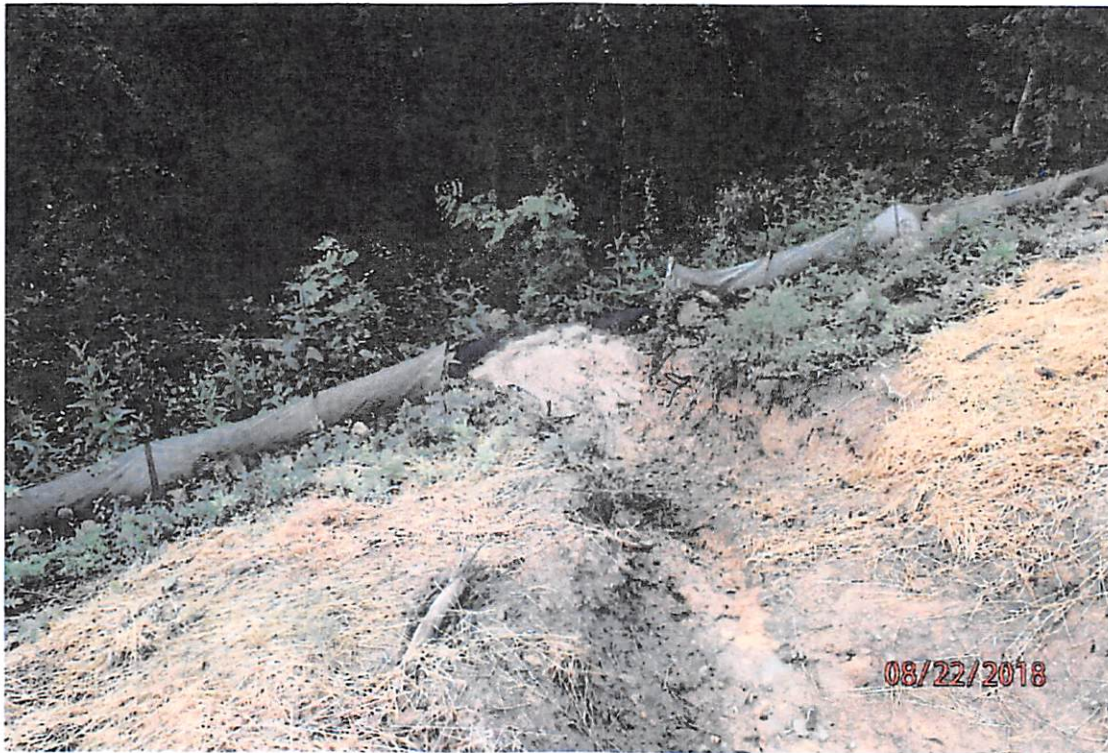
Diversion berm outlet near 57+00 that has been overwhelmed. Offsite sediment deposits were noted.

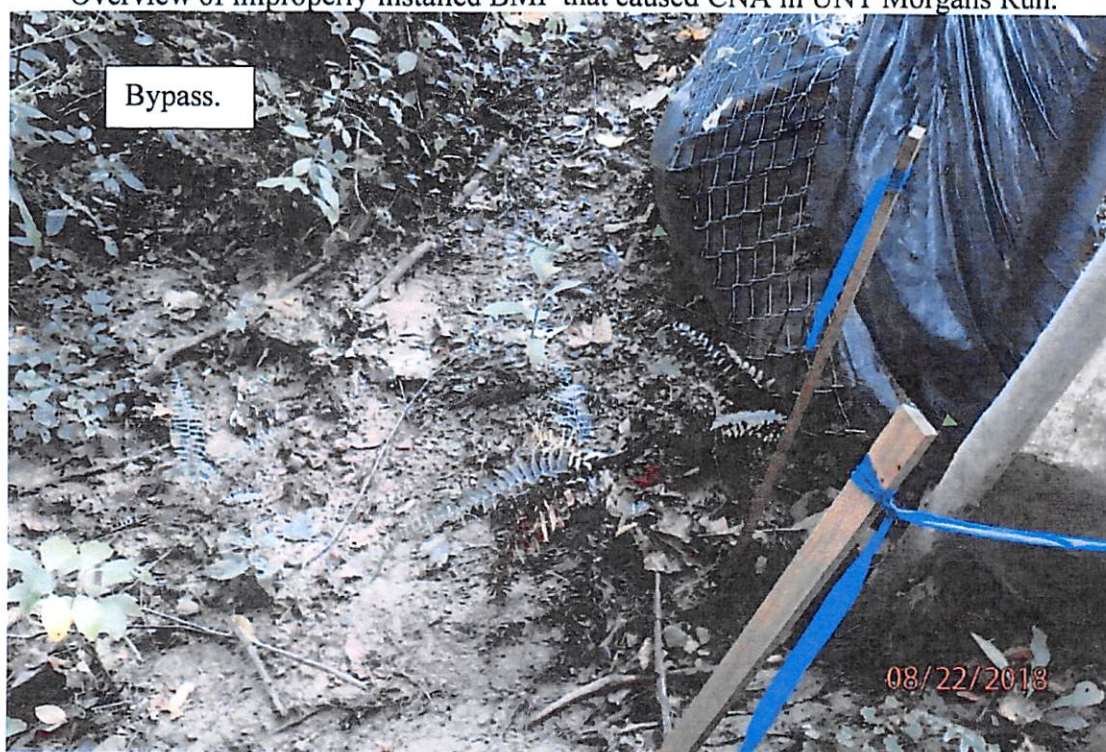
Overview of improperly installed BMP that caused CNA in UNT Morgans Run.

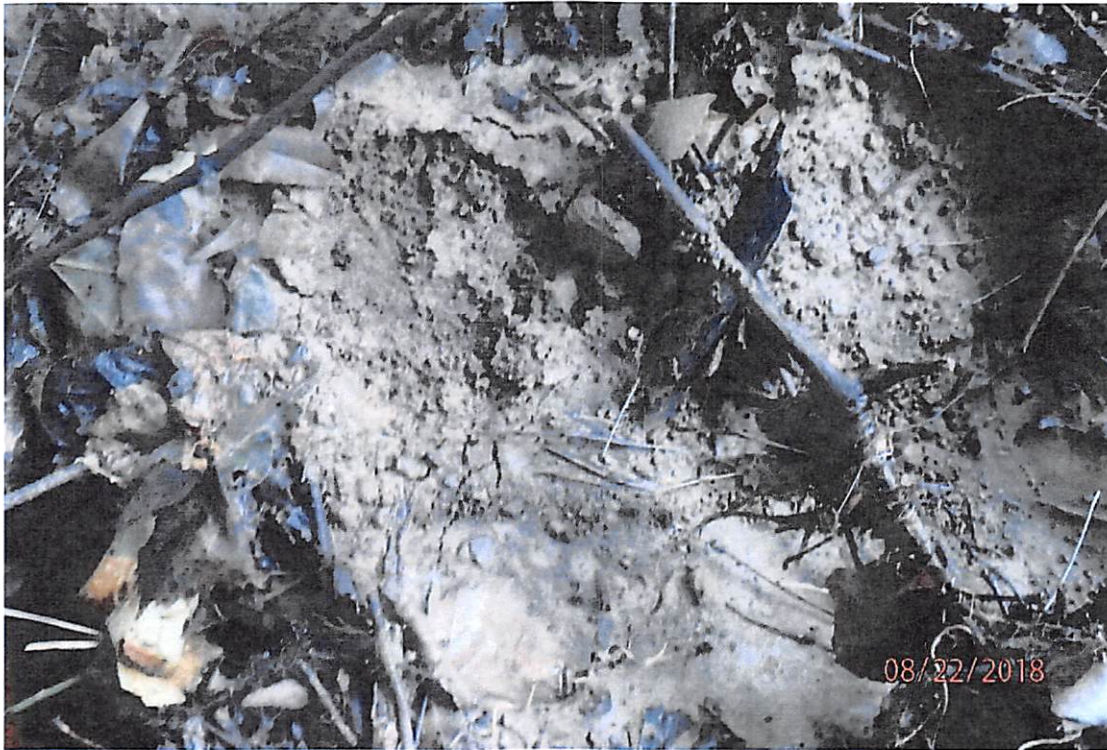
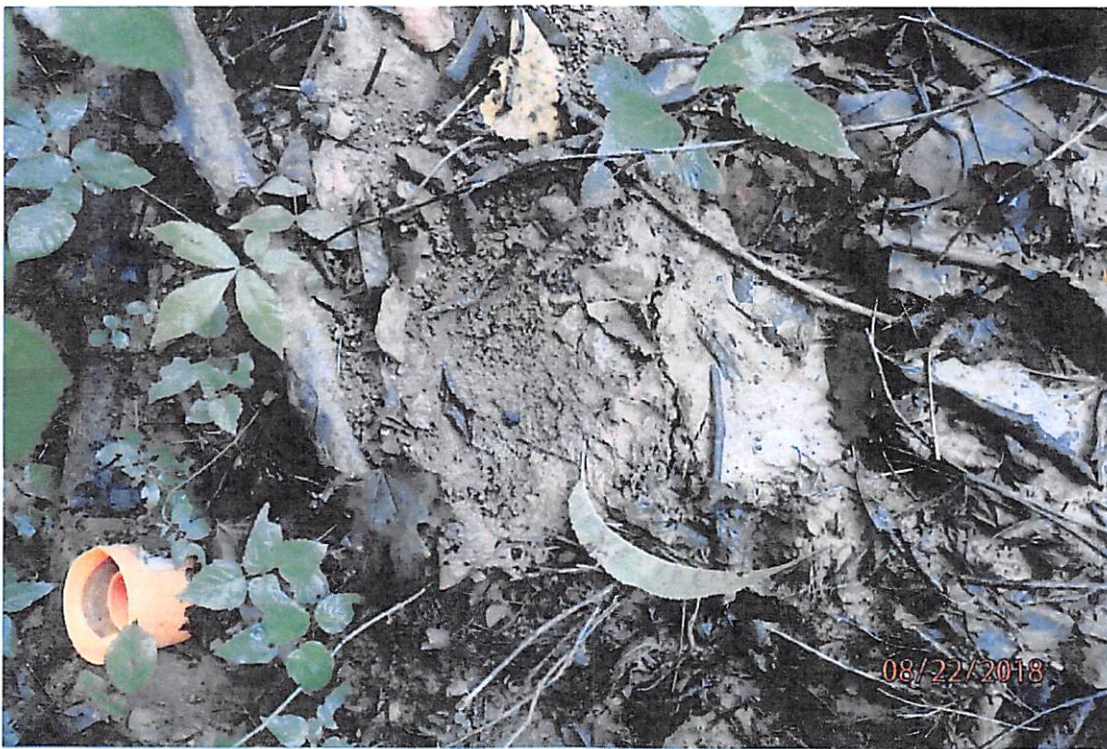
Overview of improperly installed BMP that caused CNA in UNT Morgans Run showing offsite sediment deposits and areas of bypass.

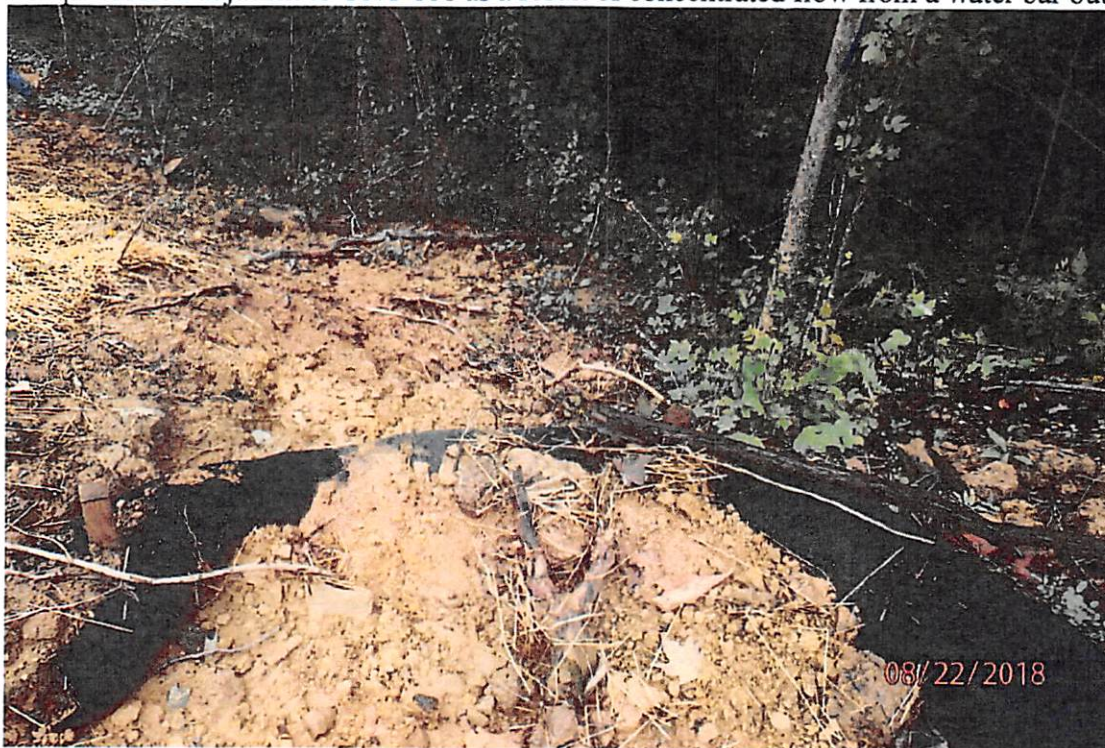
Fill slope erosion adjacent to UNT 108 as a result of concentrated flow from a water bar outlet.

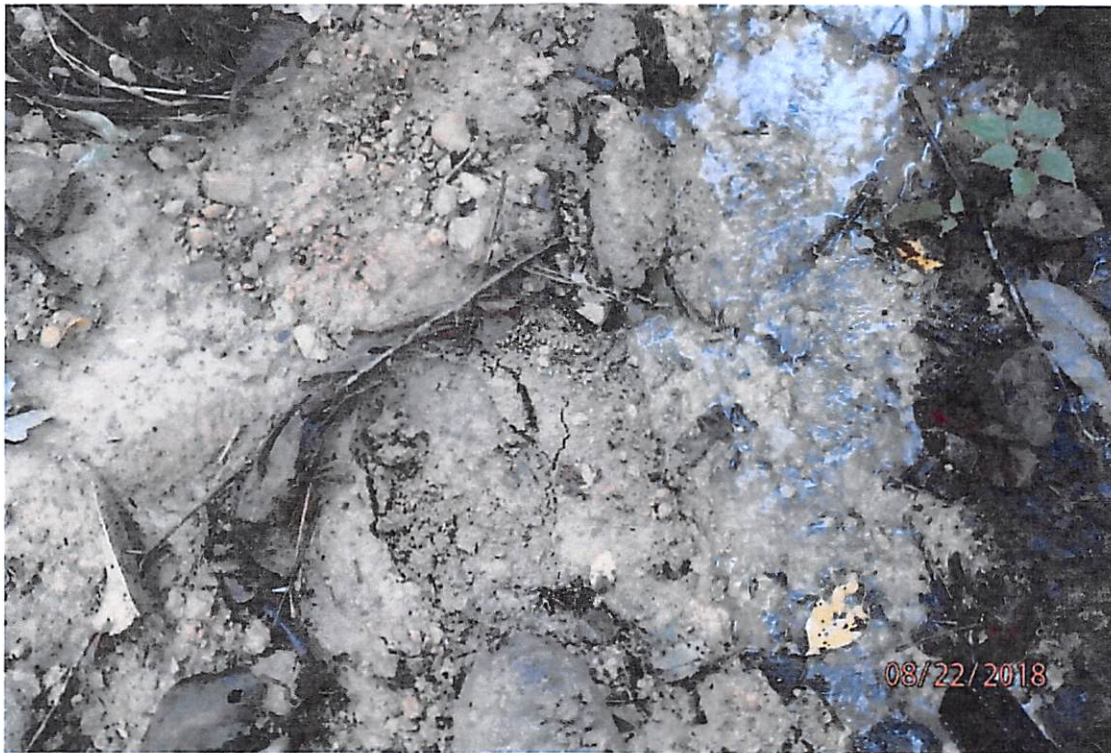
BMP that has been overwhelmed as a result of the above pictured fill slope erosion. Offsite sediment deposits leading to the receiving stream were noted.

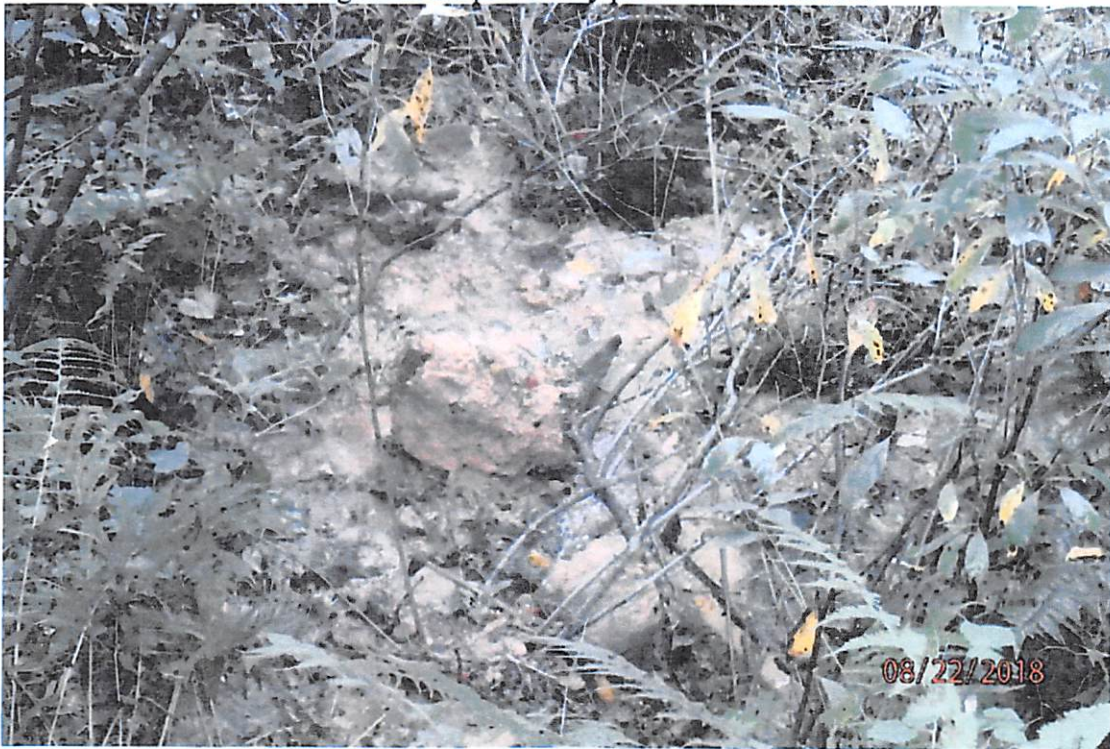
Offsite CNA deposits in UNT Righthand Fork of Morgans Run (UNT 108) (39° 17.955' X 80° 40.580')
resulting from the previously pictured deficiencies.

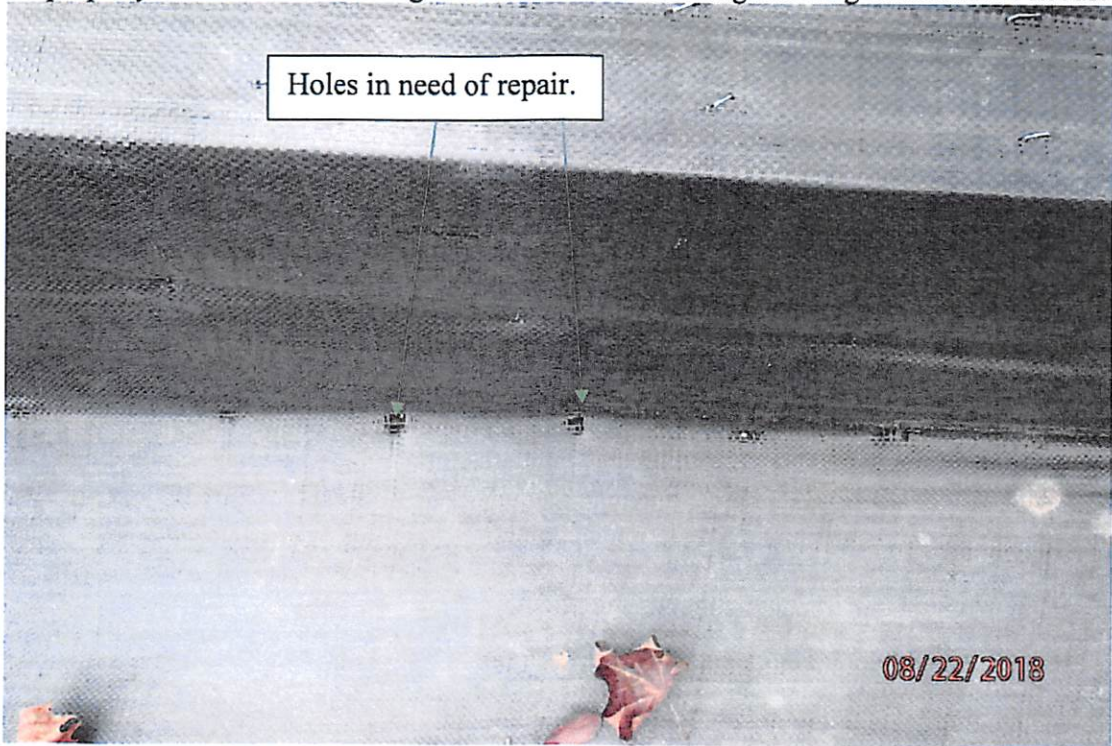
Improperly installed timber bridge at the Flint Run crossing showing maintenance needs.

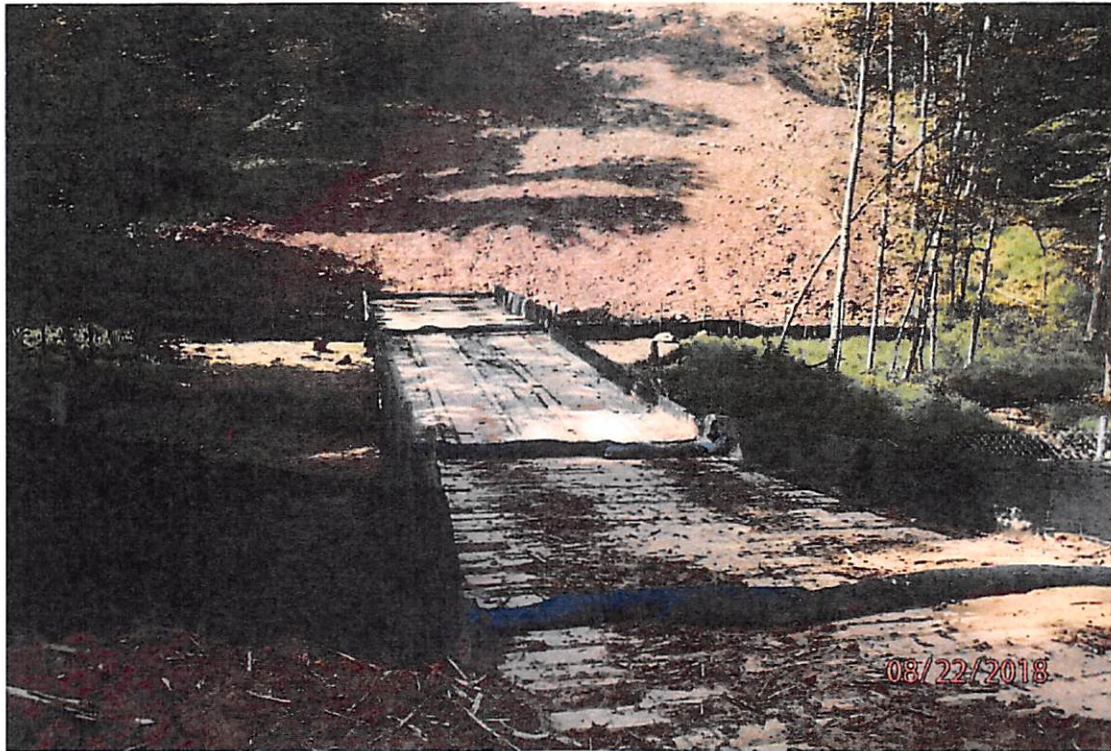
Improperly installed timber bridge at the Flint Run crossing showing maintenance needs.

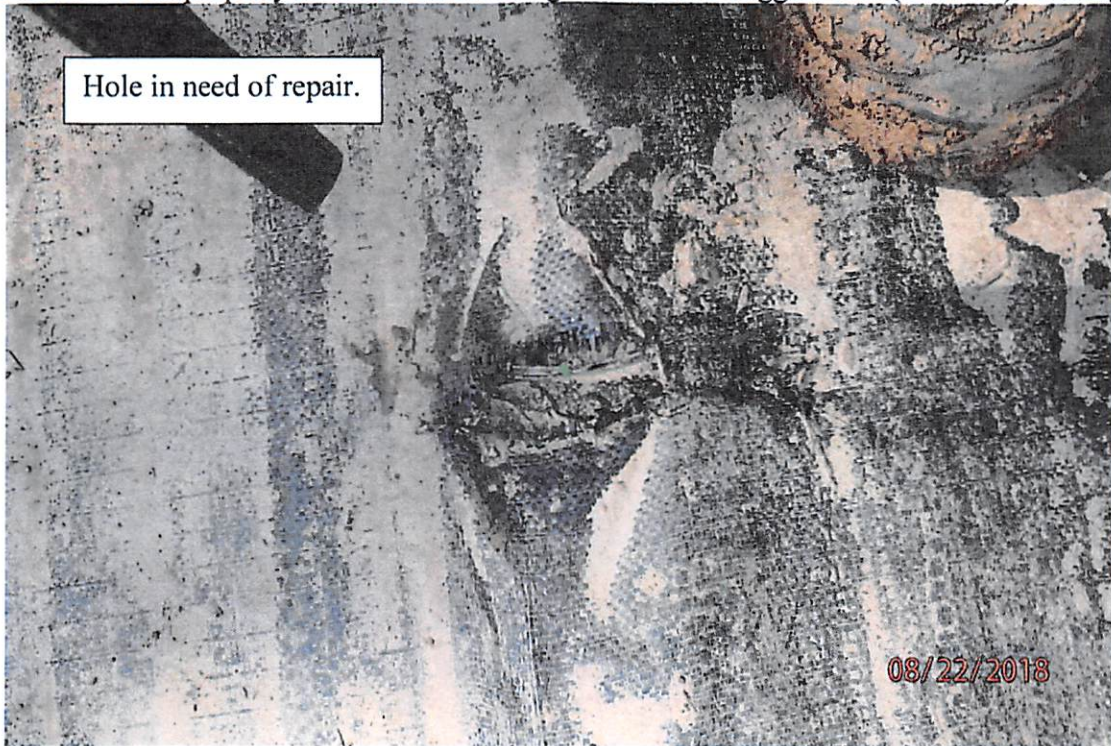
Overview of improperly installed timber bridge at the UNT Riggins Run (UNT 98) crossing.

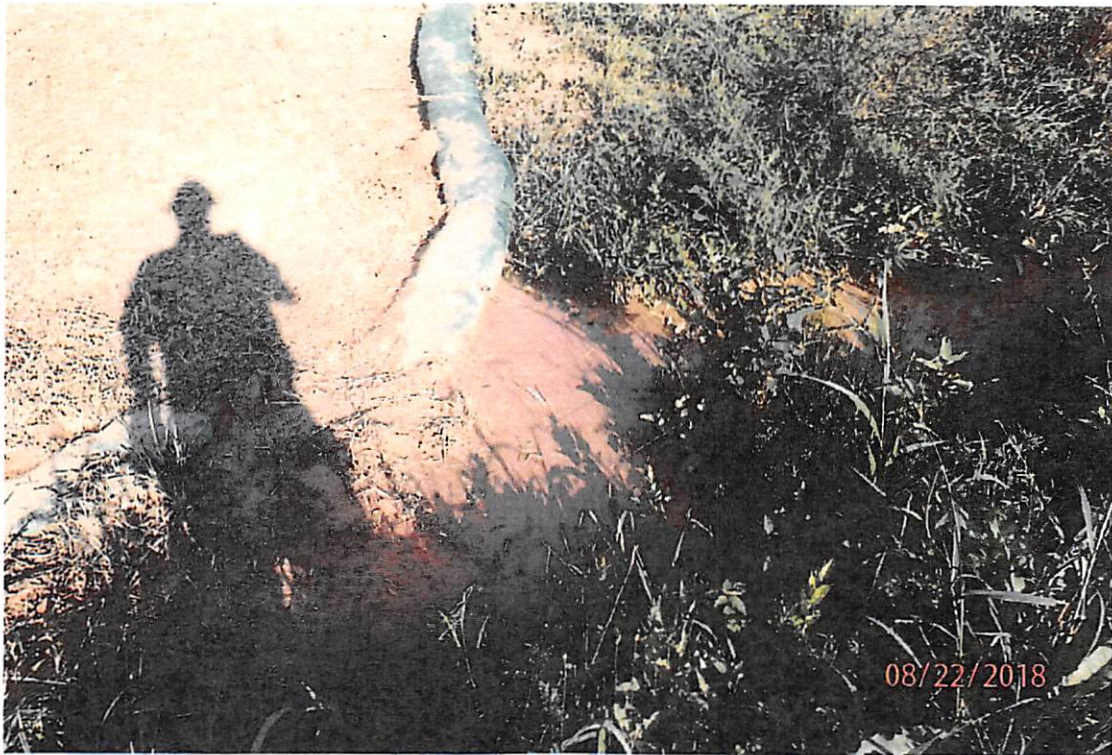
AR 40 showing a lack of stabilization that is described in the approved SWPPP.

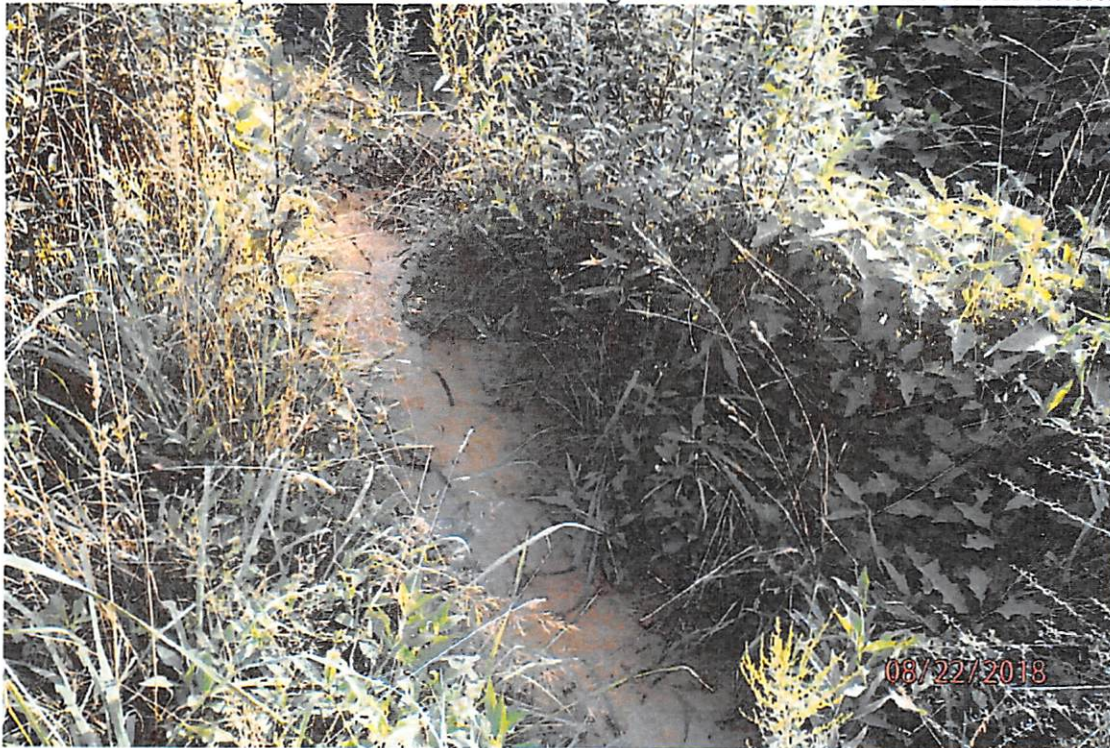
Offsite sediment deposits that lead to the receiving stream as a result of AR 40 deficiencies.

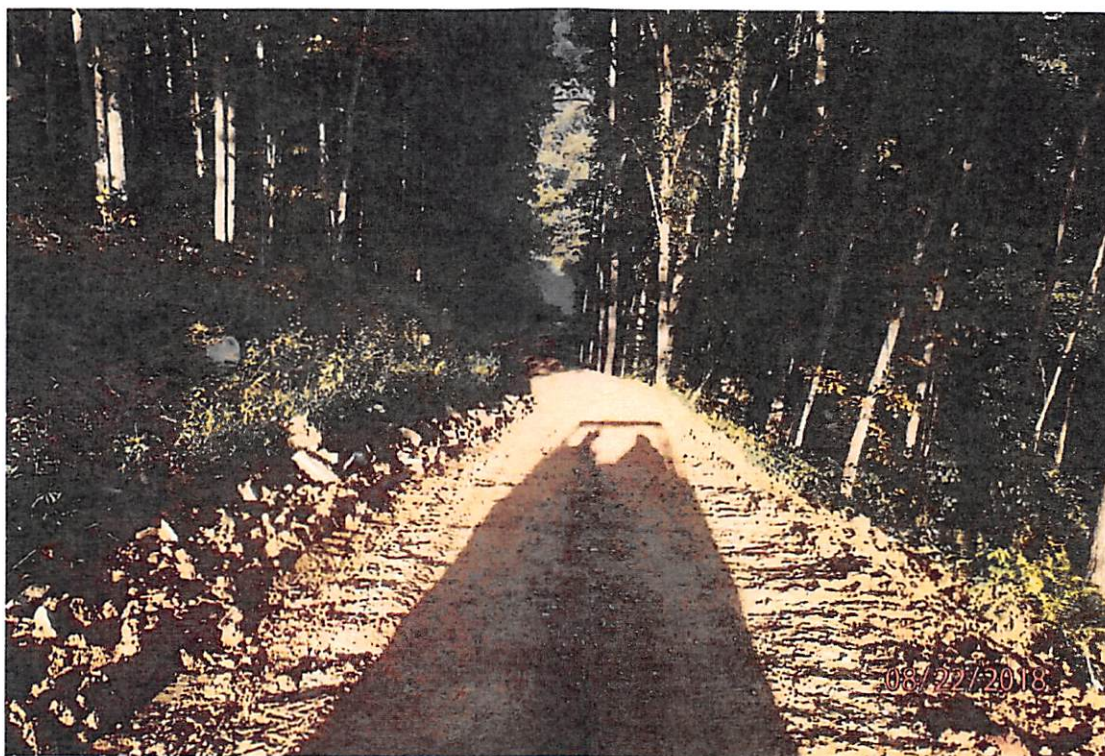
Offsite sediment deposits that lead to the receiving stream as a result of AR 40 deficiencies.

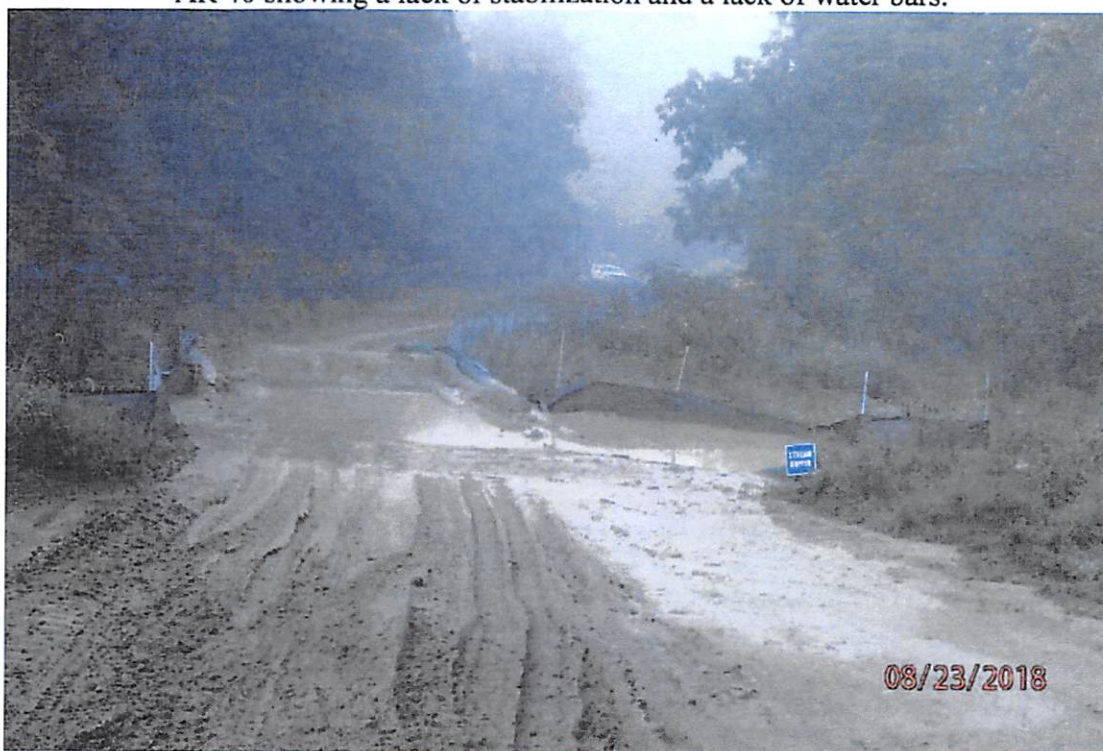
AR 40 showing a lack of stabilization and a lack of water bars.

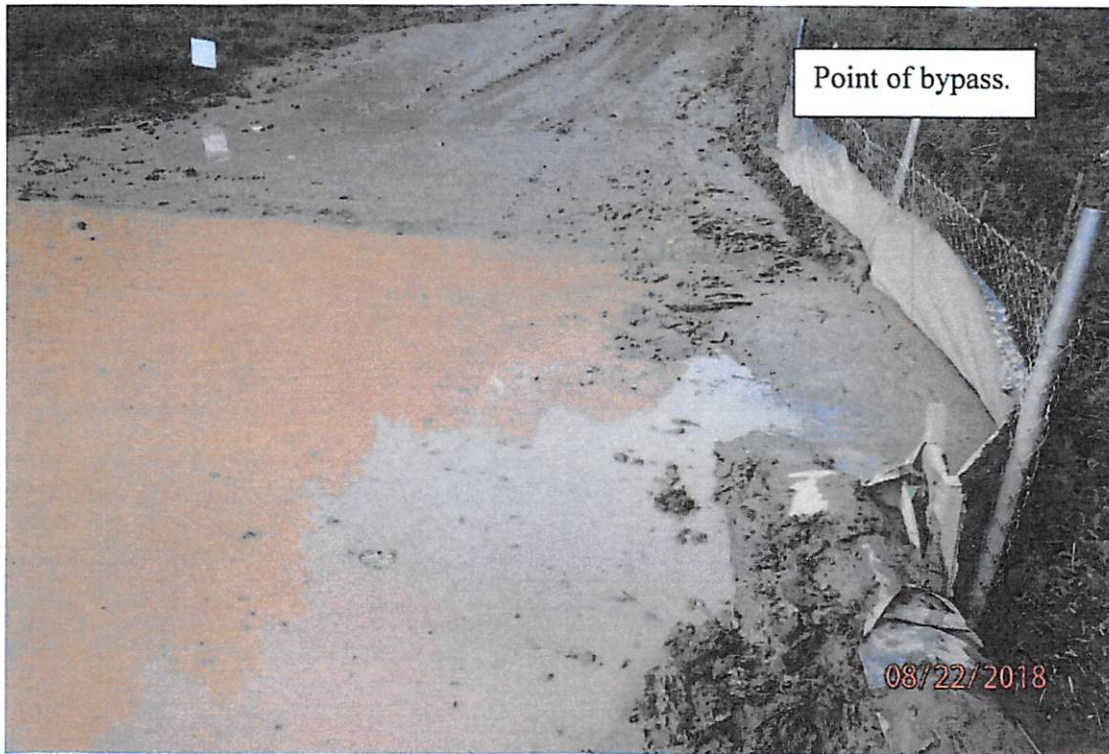
UNT 127 crossing on AR 40 showing area where CNA occurred as a result of above pictured deficiencies.

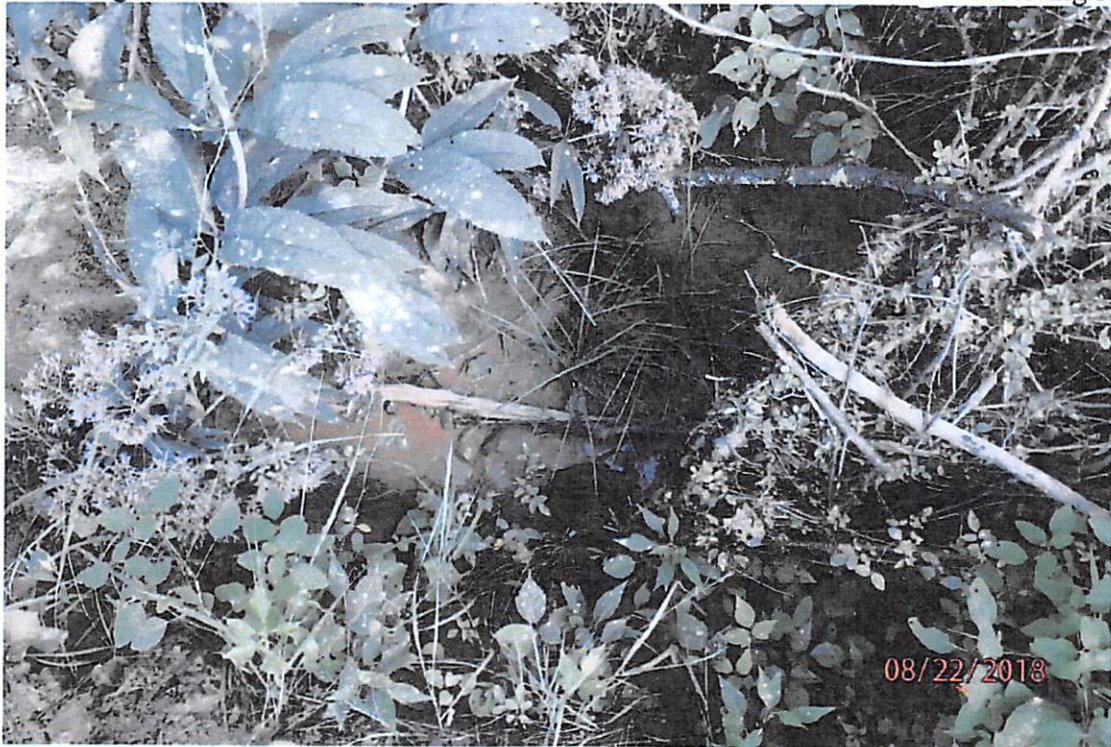
AR 40 crossing of UNT 127 where BMP failure allowed sediment to leave site into receiving stream.

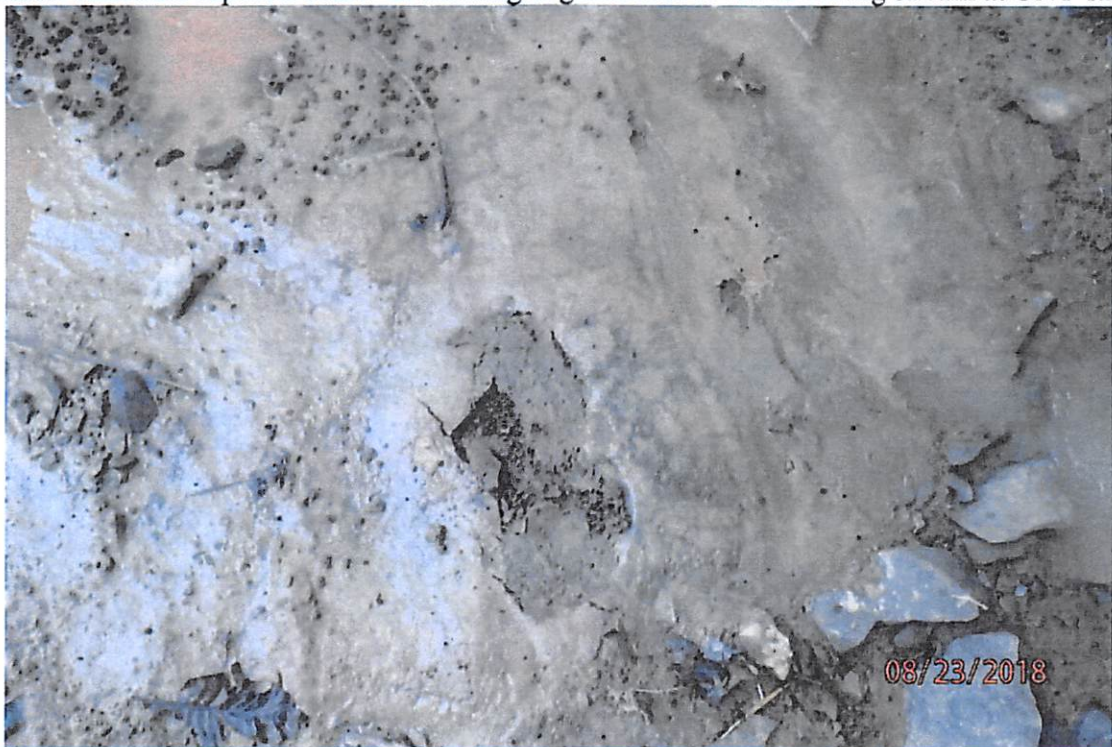
Offsite sediment deposits below dewatering bag that lead to the receiving stream at UNT 129.

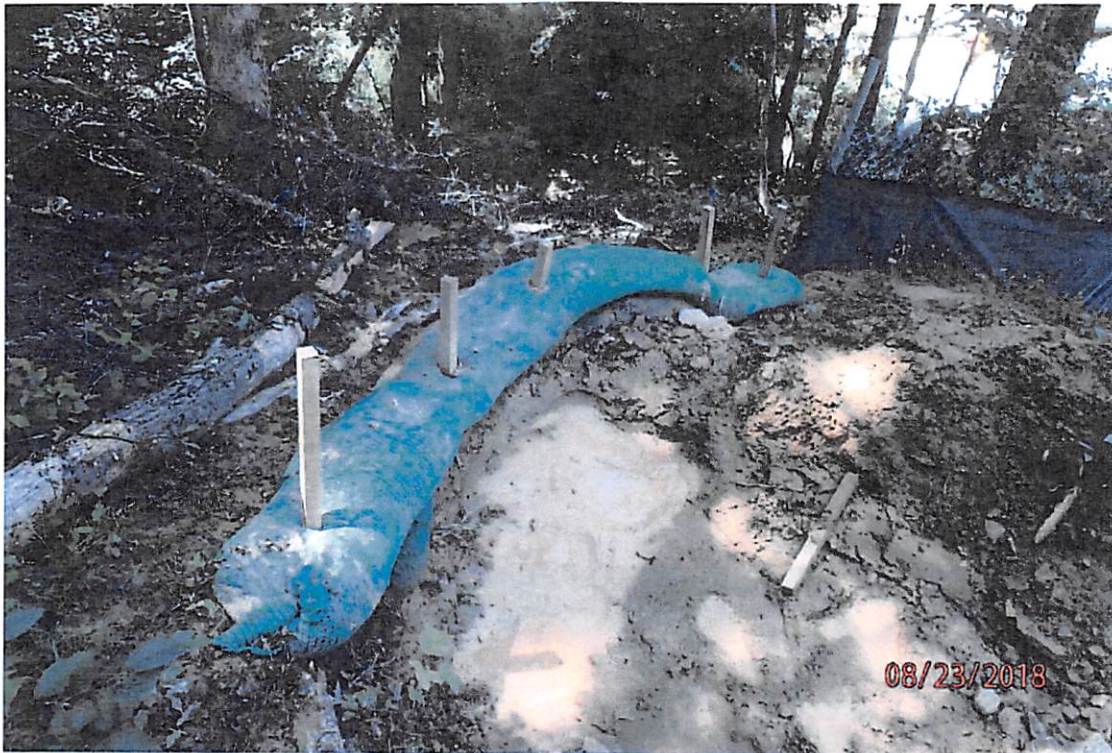
BMPs that were overwhelmed due to flow from the open pipe trench adjacent to crossing #23 (UNT 133)
that led to offsite CNA.

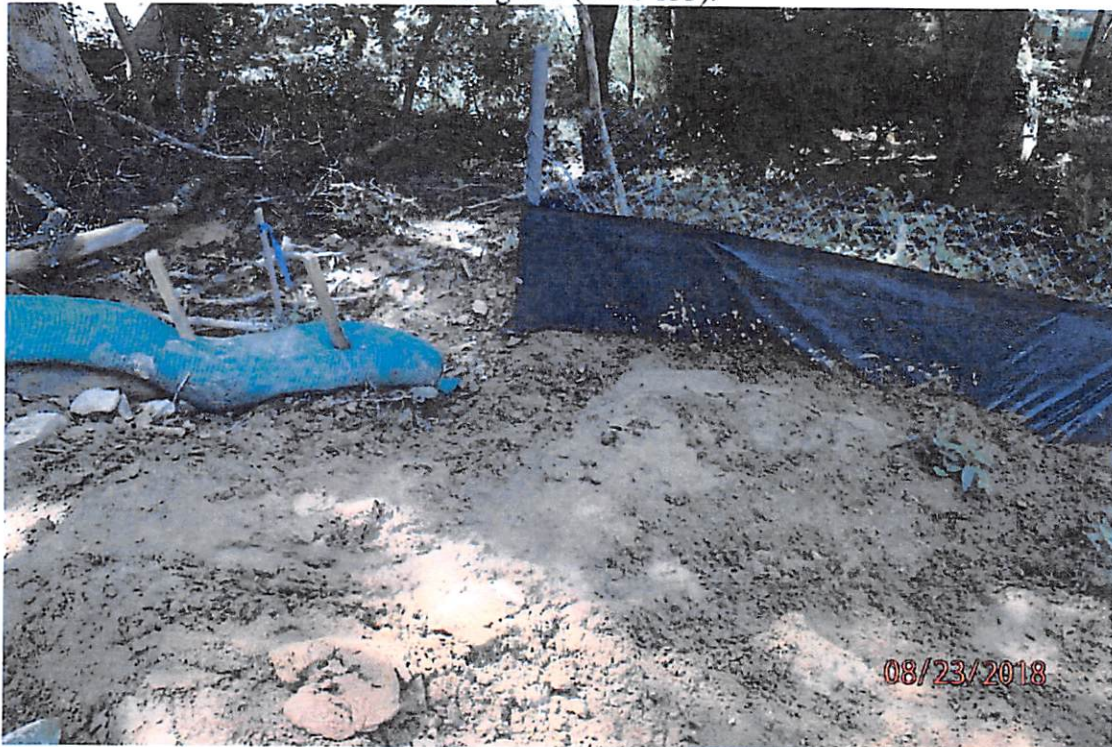
Improperly installed water bar terminus BMP that allowed sediment laden water to bypass it adjacent to crossing #23 (UNT 133).

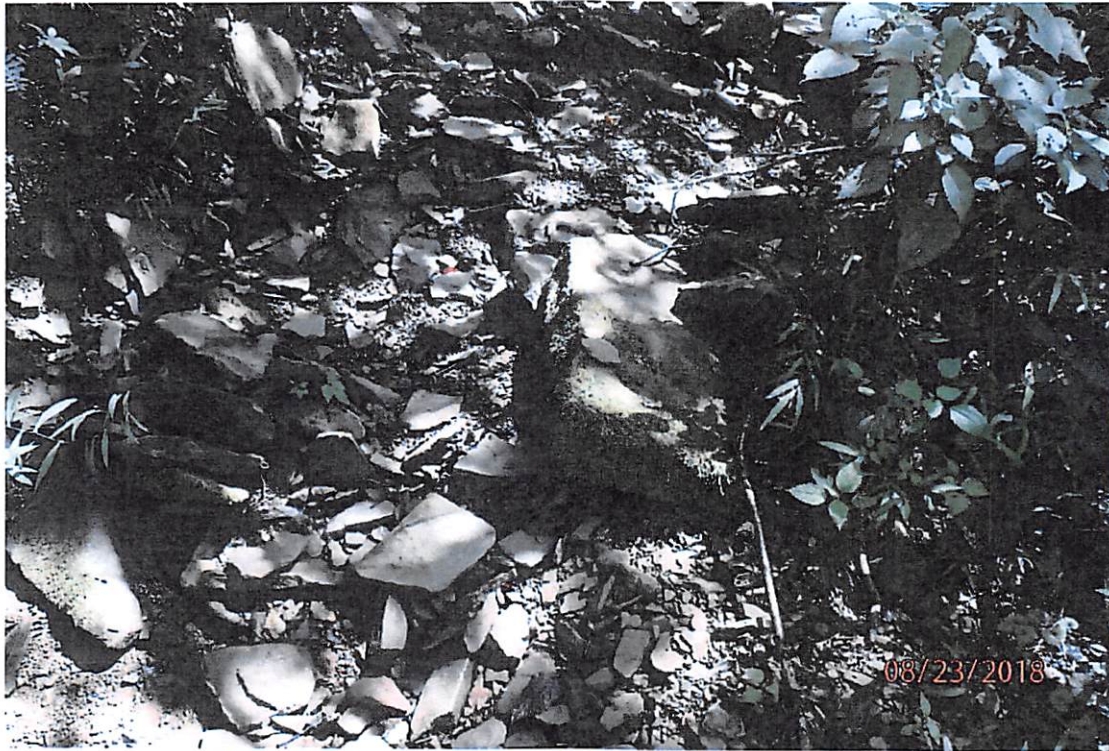
Improperly installed water bar terminus BMP that allowed sediment laden water to bypass it adjacent to crossing #23 (UNT 133).
